**US Army Corps
of Engineers**

**Shinnecock Inlet, New York,
Site Investigation**

**Report 1
Morphology and Historical Behavior**

by Andrew Morang

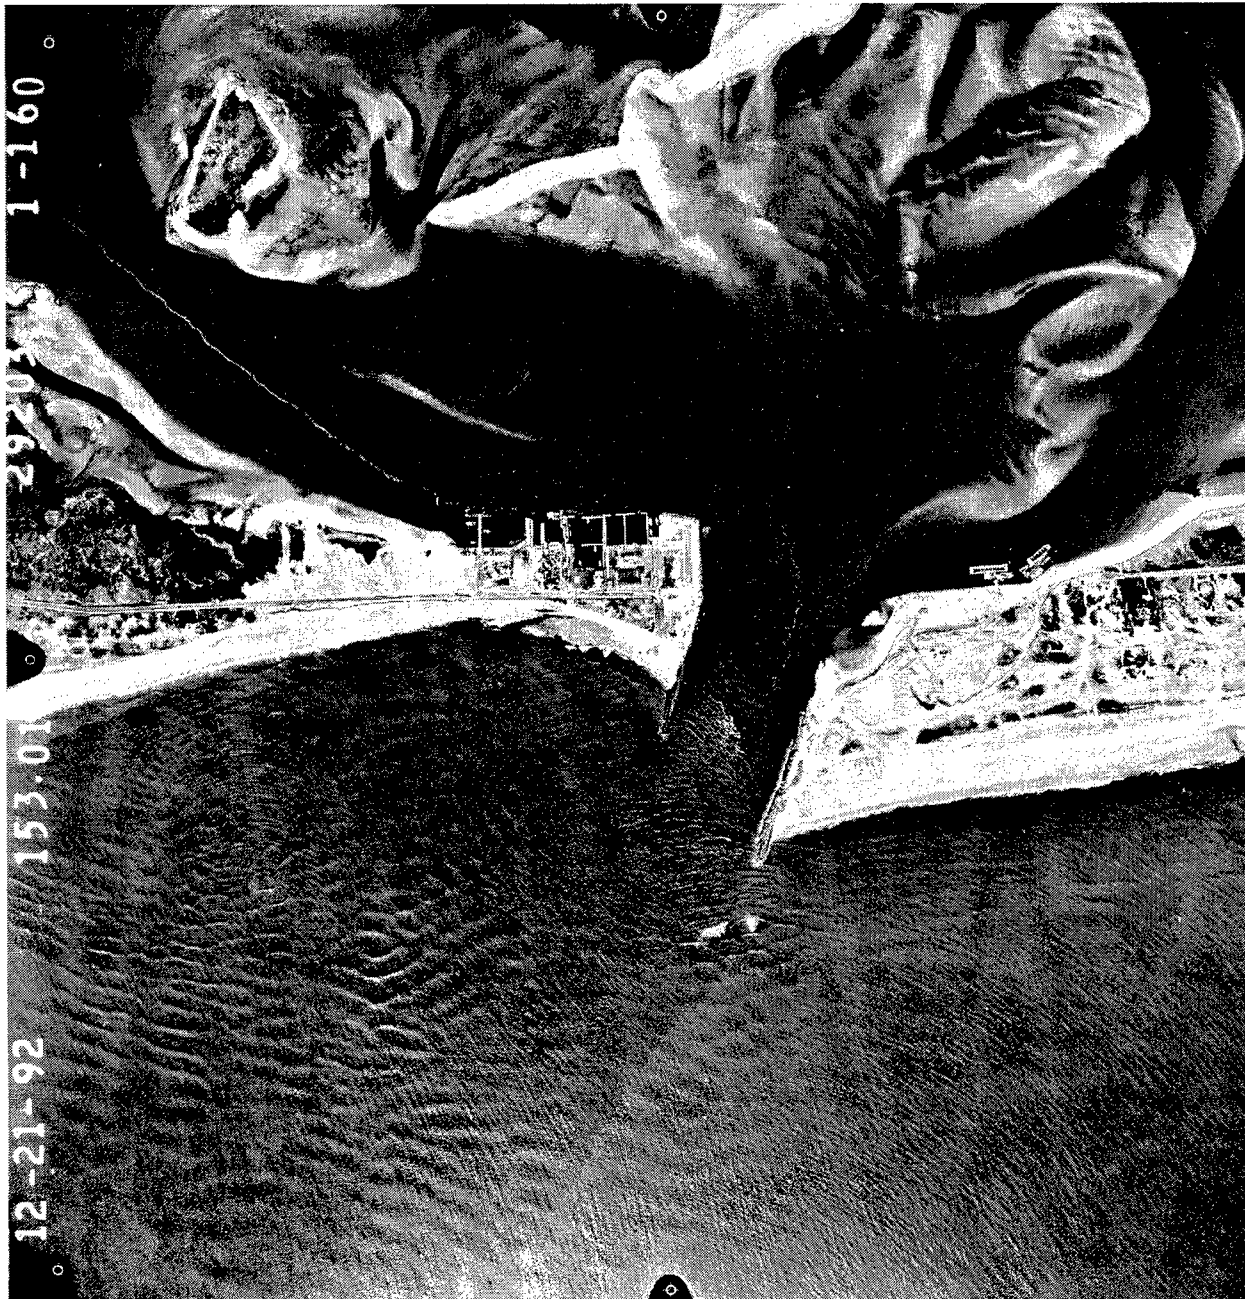
Figure A40. 21 December 1992 (Similar conditions as previous photographs taken 3 days earlier. Waves still appear to be concentrated along the east shore where part of the jetty has failed. T-shaped sandbar in flood shoal has been divided into two sections)

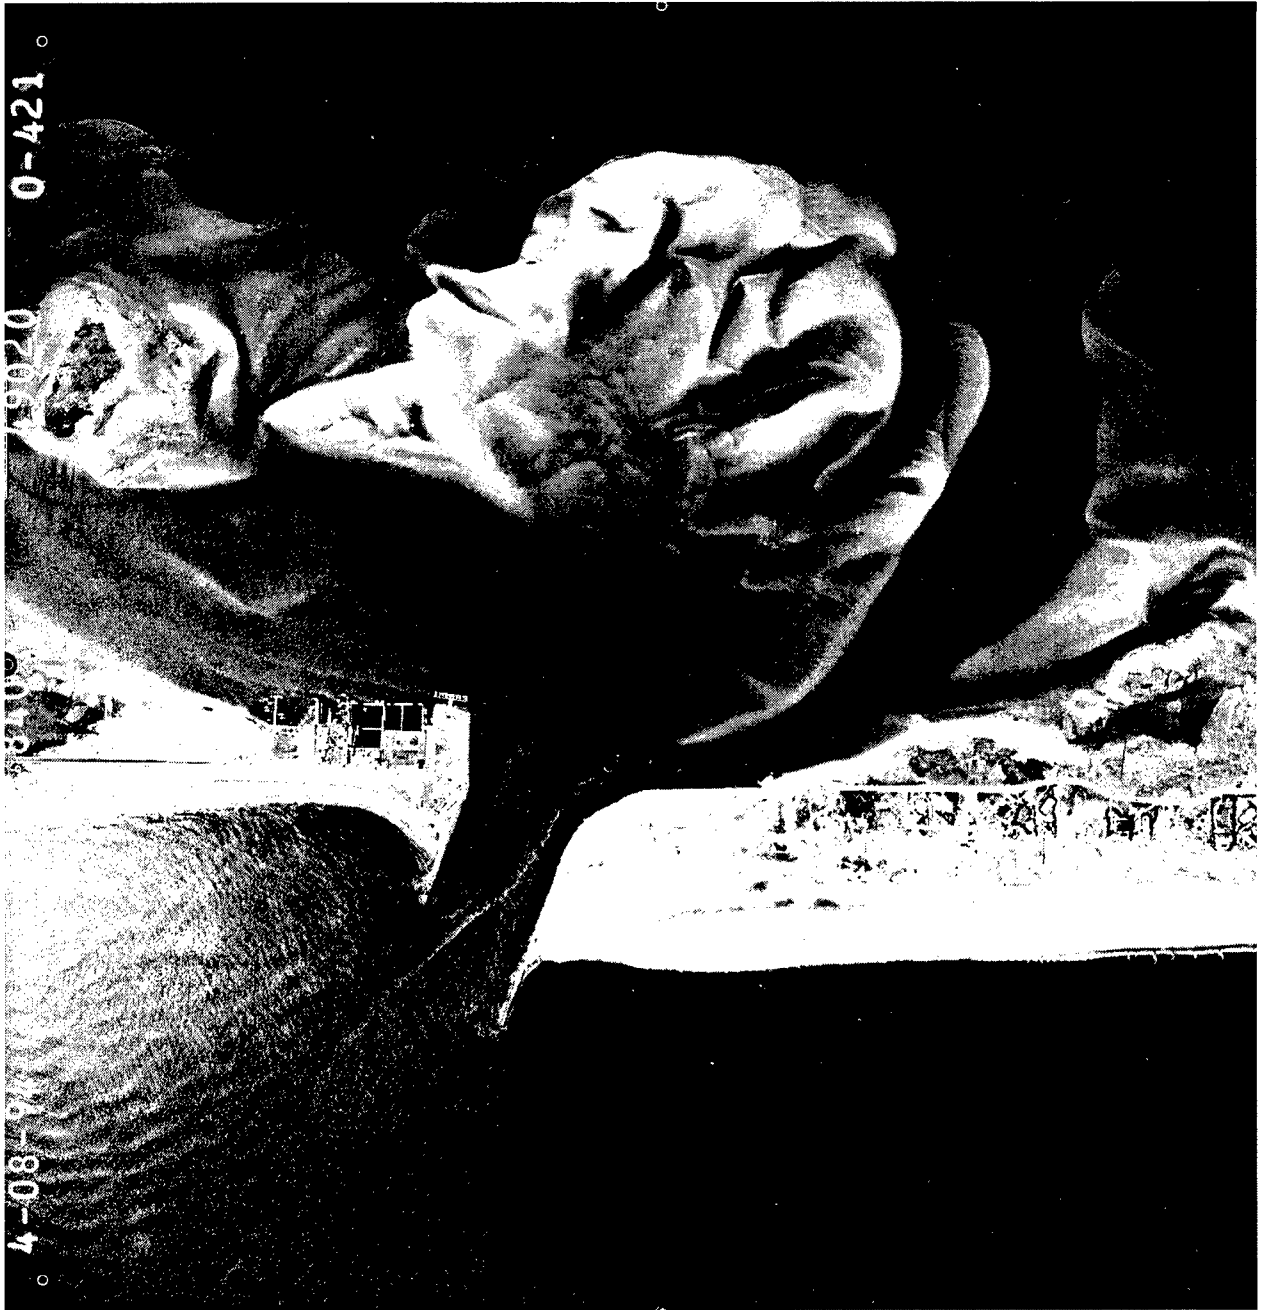
Figure A43. 8 April 1994 (West beach has eroded again, and east beach has also retreated. Repair of east jetty and revetment is complete. Repairs are underway on west jetty, and rock and materials are stockpiled in parking lot)

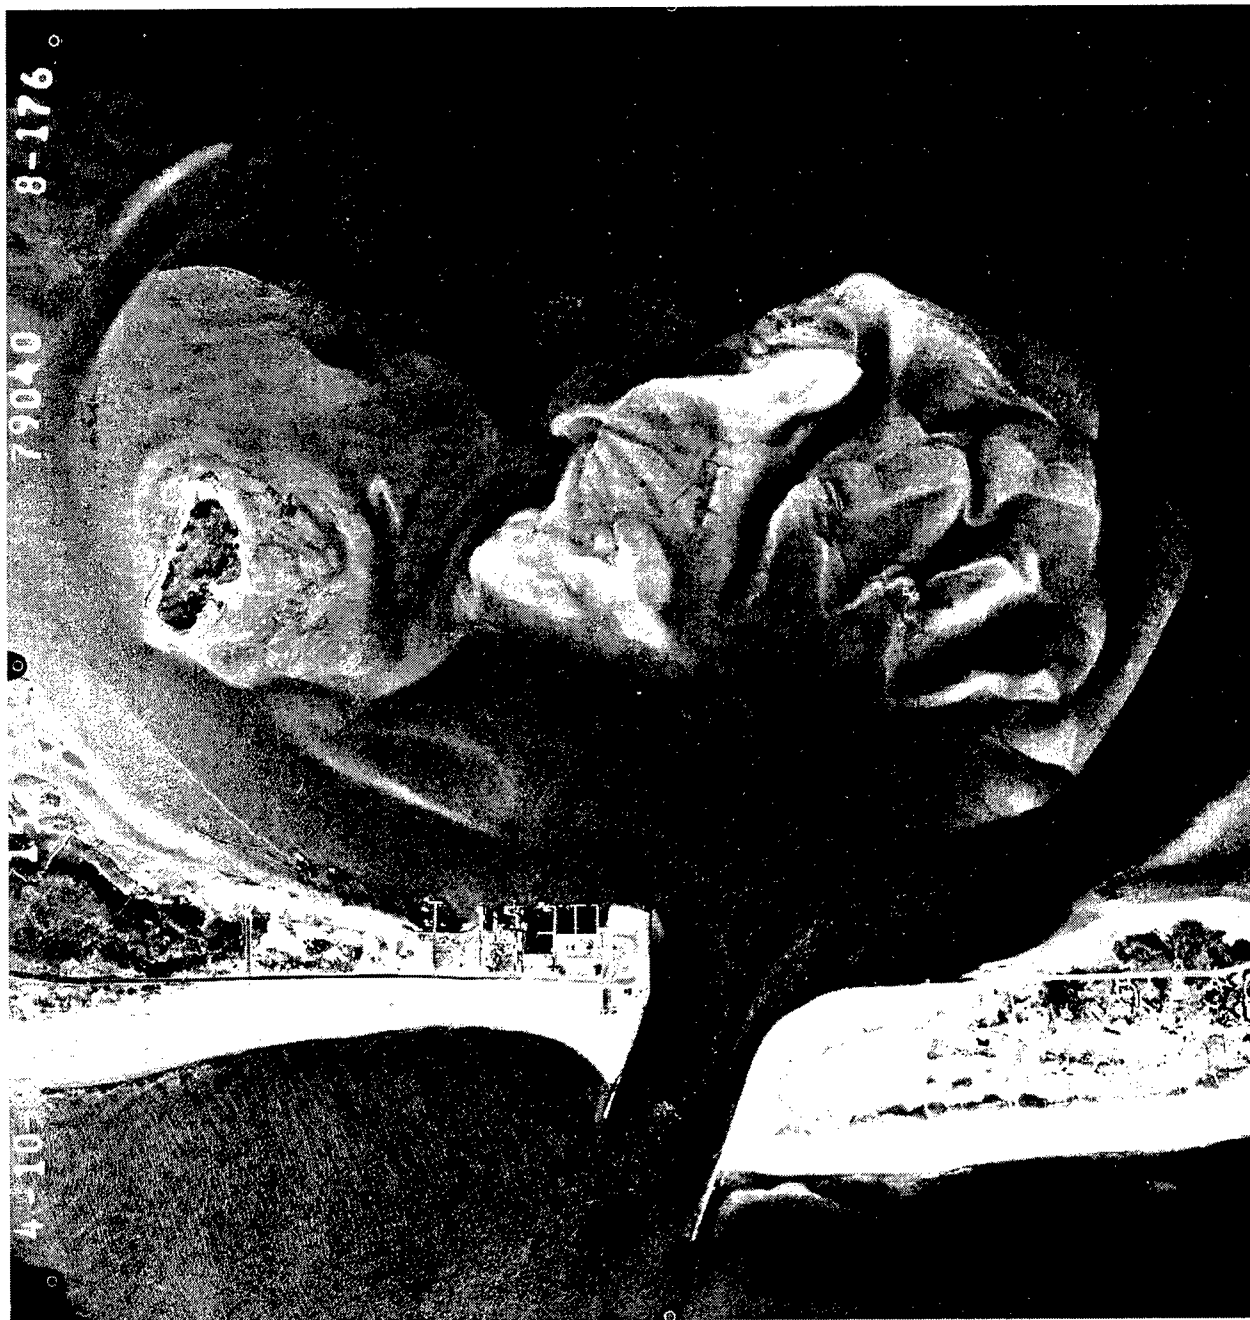
Figure A49. 10 April 1997 (East beach has receded about 100 m from tip of west jetty. West beach was repaired with sand dredged from channel in February and March (see Table D1). Active portion of flood shoal is now symmetrically positioned in line with axis of inlet. This is east of its 1970s position)

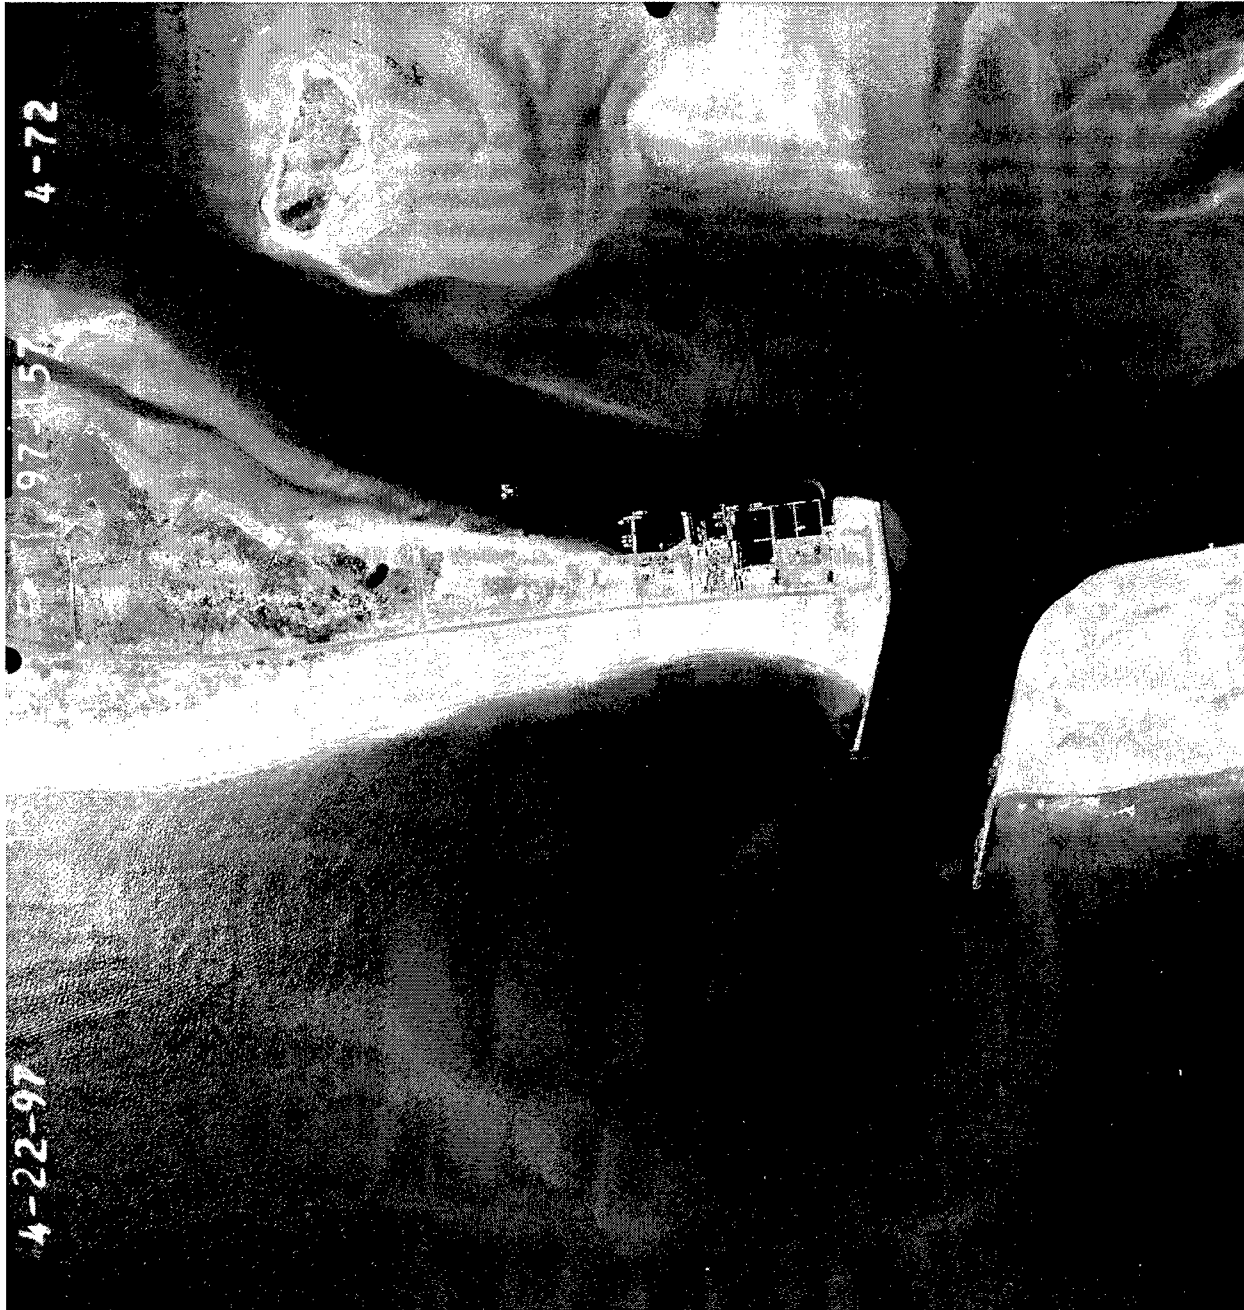
Figure A50. 22 April 1997 (Edge of ebb shoal is clearly visible in this image, taken on a day with almost no waves. Water depth at the bar is about 3 m (10 ft). Dark water off the mouth of the inlet is the dredged deposition basin. A ridge of sand that projects seaward from the west jetty and a deep hole to its west were measured by bathymetric surveys (see Appendix B))
